FINAL REPORT

INTERSECTION

DESIGN

NEW JERSEY DEPARTMENT OF TRANSPORTATION

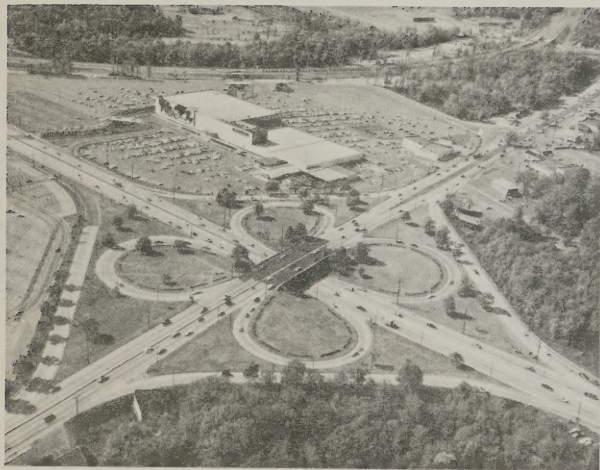
Cloverleaf

Year of Construction: 1933

Photographed 6/1/67 - 1630 hours
600' Altitude, Looking Northwest

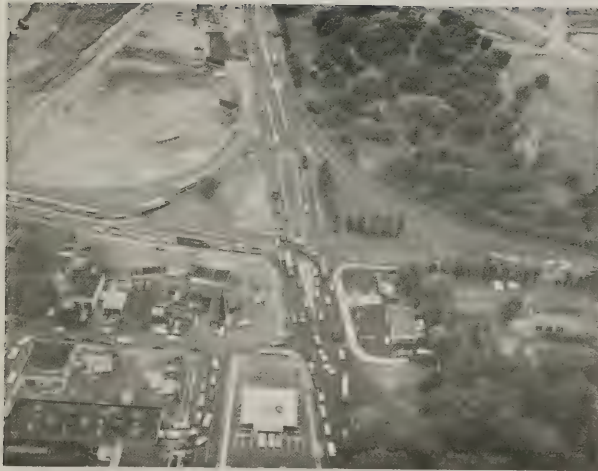
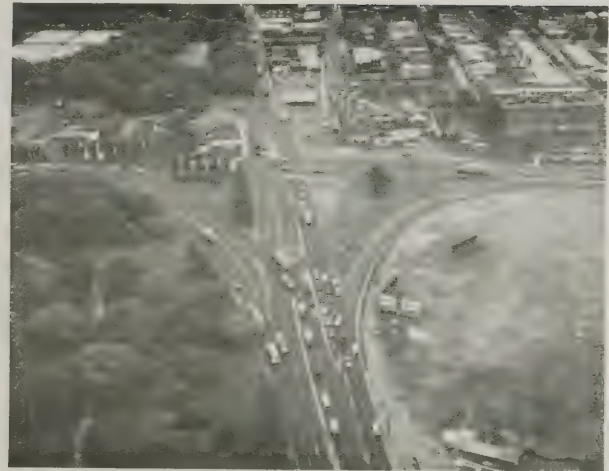
Signalized Channelized Intersection

Year of Construction: 1954

Photographed 6/29/67 - 1600 hours
700' Altitude, Looking West

Photographed 6/29/67 - 1600 hours
500' Altitude, Looking East

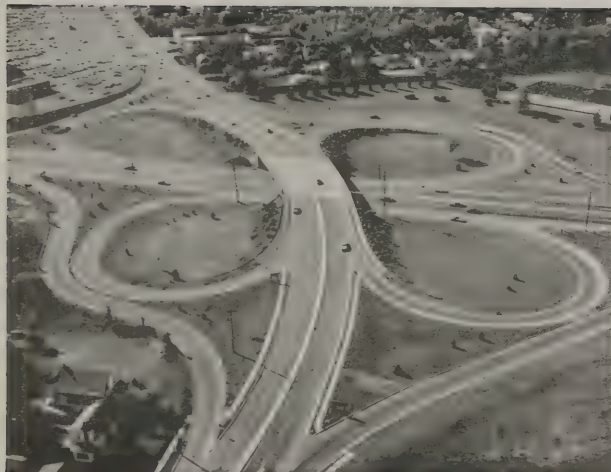
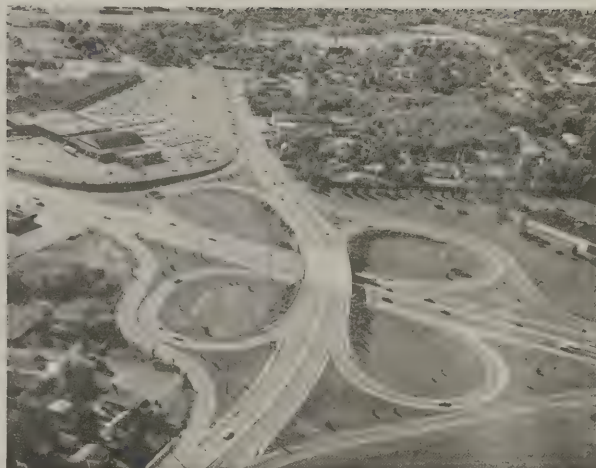
Cloverleaf

Year of Construction: 1960

Photographed 6/1/67 - 1730 hours
500' Altitude, Looking West

Photographed 6/1/67 - 1730 hours
700' Altitude, Looking West

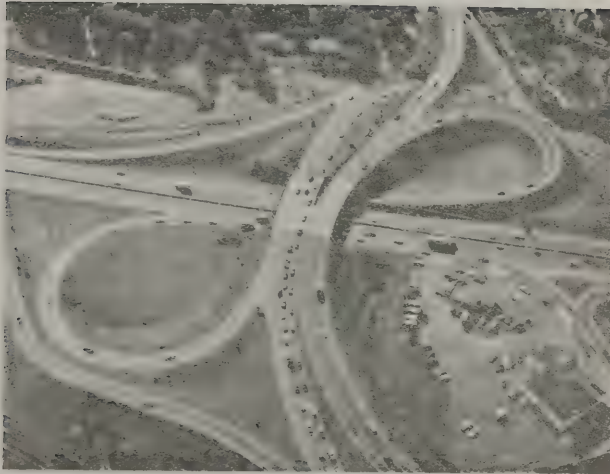
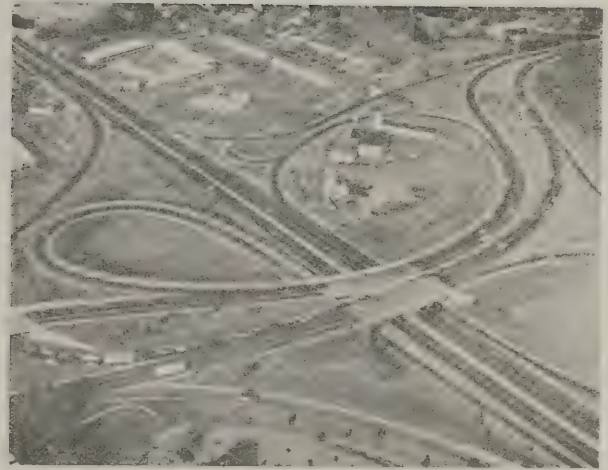
Cloverleaf

Year of Construction: 1960

Photographed 6/1/67 - 1730 hours
600' Altitude, Looking West

Photographed 6/1/67 - 1730 hours
800' Altitude, Looking Northeast

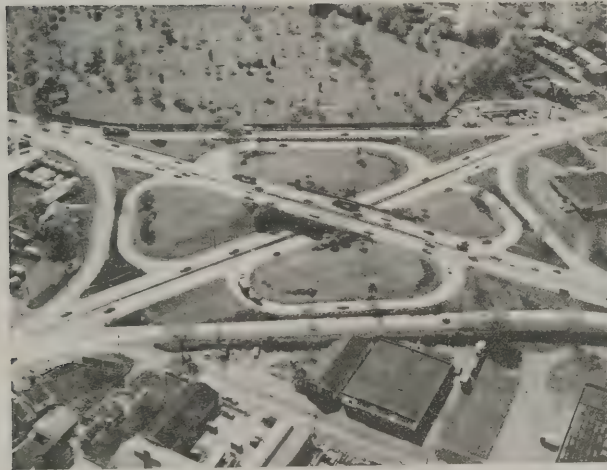
PHOTO 4

U.S. Route 1-9 and N.J. Route 35

Cloverleaf

Year of Construction: 1928

Photographed 5/18/67 - 1700 hours
600' Altitude, Looking West

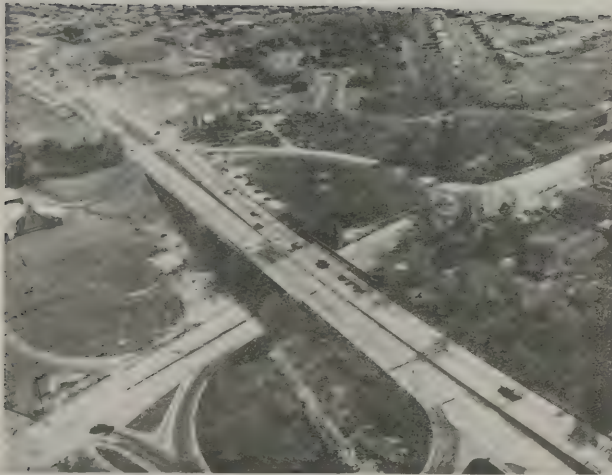
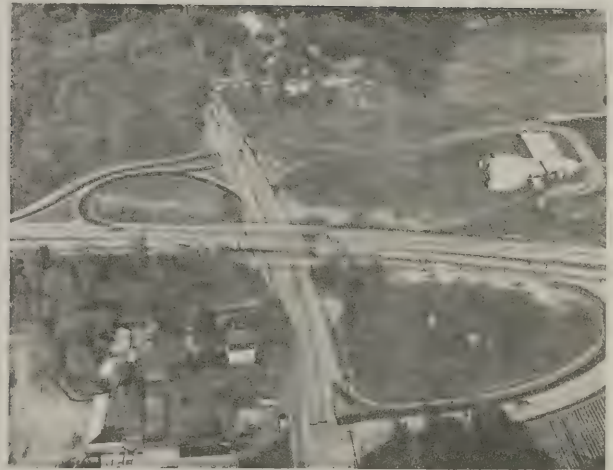
Partial Cloverleaf

Year of Construction: 1942

Photographed 5/17/68 - 0900 hours
500' Altitude, Looking South

Photographed 5/17/68 - 0900 hours
700' Altitude, Looking East

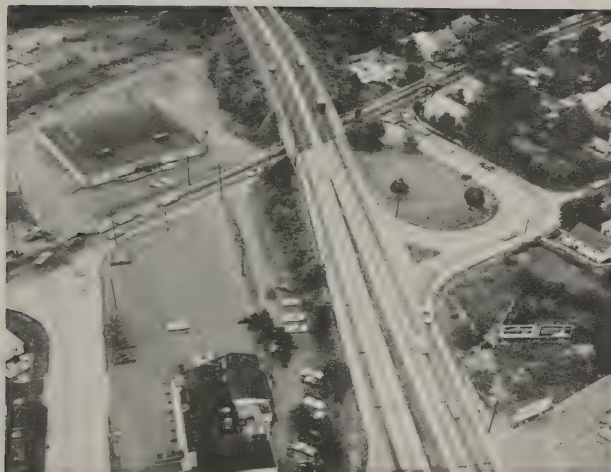
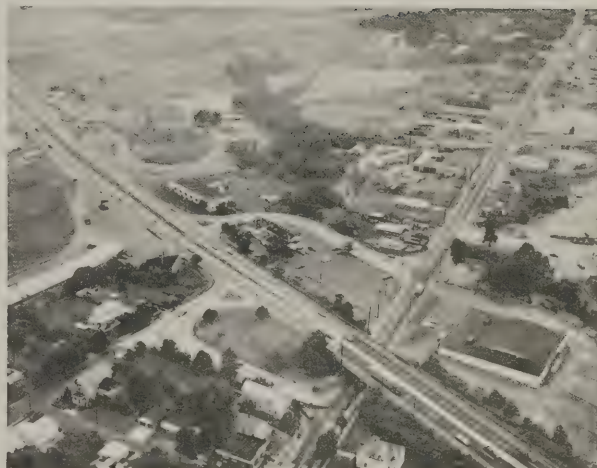
Partial Cloverleaf

Year of Construction: 1938

Photographed 5/17/68 - 0830 hours
500' Altitude, Looking North

Photographed 5/17/68 - 0830 hours
800' Altitude, Looking Southwest

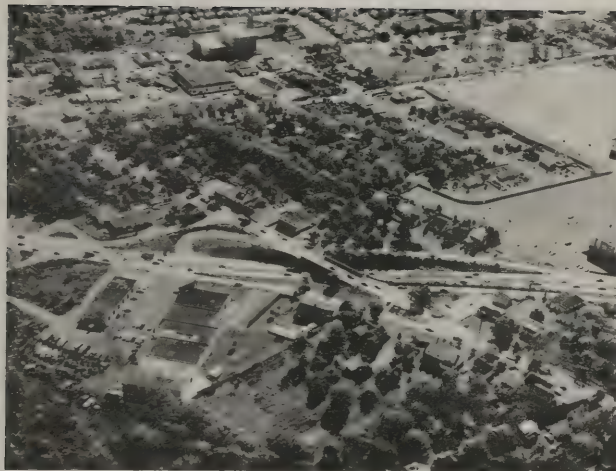
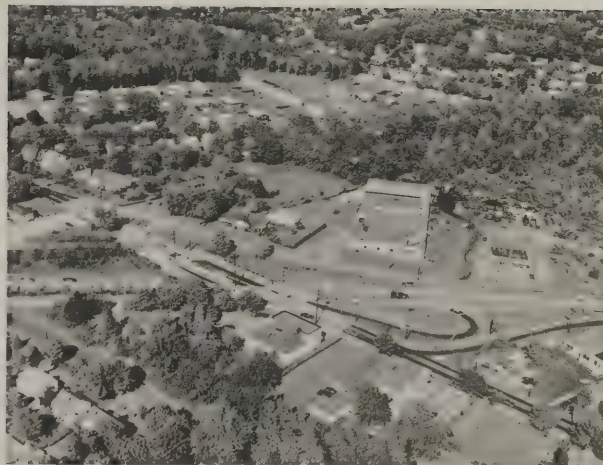
Diamond with Loop Ramp

Year of Construction: 1957

Photographed 8/21/67 - 1630 hours
800' Altitude, Looking West

Photographed 8/21/67 - 1630 hours
800' Altitude, Looking East

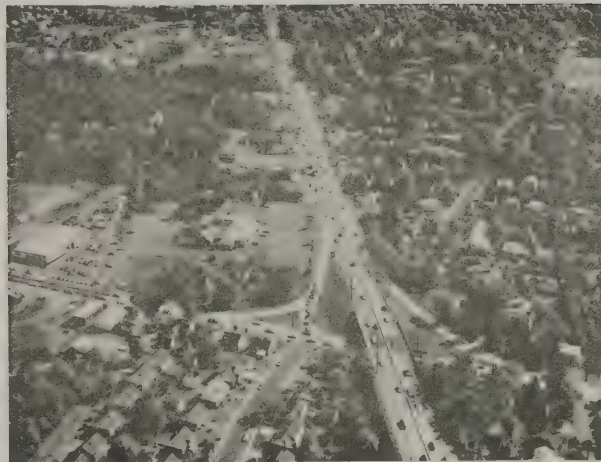
Photographed 8/21/67 - 1630 hours
800' Altitude, Looking South

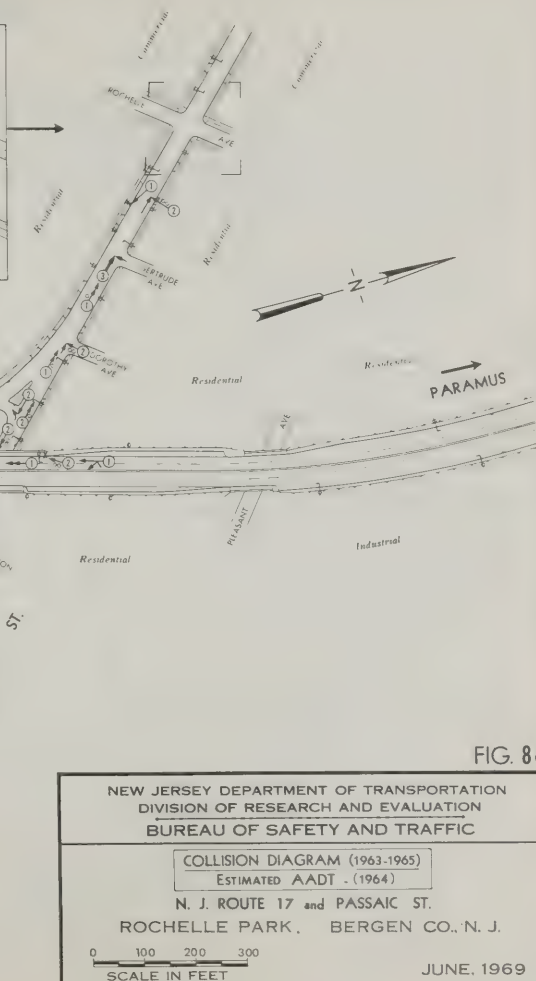
FIG. 8c

ACCIDENT SUMMARY (1963-1965)				FATAL	INJURY	PROPERTY DAMAGE
TYPE OF ACCIDENT	DAY	NIGHT	TOTAL	→→	→○	
→ RIGHT ANGLE	29	7	36	0	16	20
→ REAR END	53	17	70	0	37	33
→ X FIXED OBJECT *	10	6	16	0	6	10
→ HEAD-ON	1	1	2	0	0	2
→ PEDESTRIAN	1	0	1	0	1	0
→ SIDESWIPe	5	1	6	0	2	4
→ LEFT TURN	5	1	6	0	0	6
→ OTHER	0	0	0	0	0	0
TOTAL	104	33	137	0	62	75

① = NUMBER OF ACCIDENTS AT EACH LOCATION

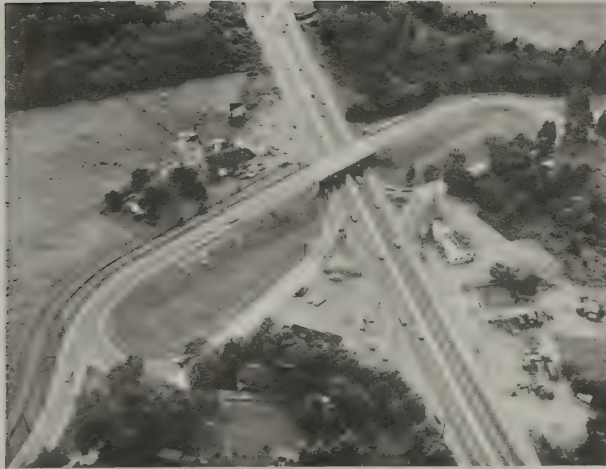
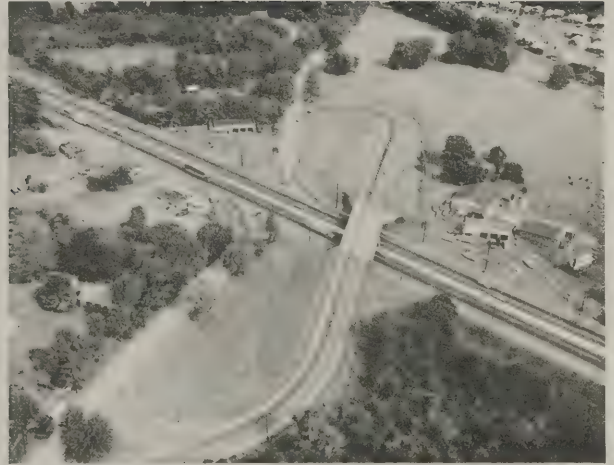
Partial Cloverleaf

Year of Construction: 1940

Photographed 8/21/67 - 1645 hours
800' Altitude, Looking West

Photographed 8/21/67 - 1645 hours
800' Altitude, Looking South

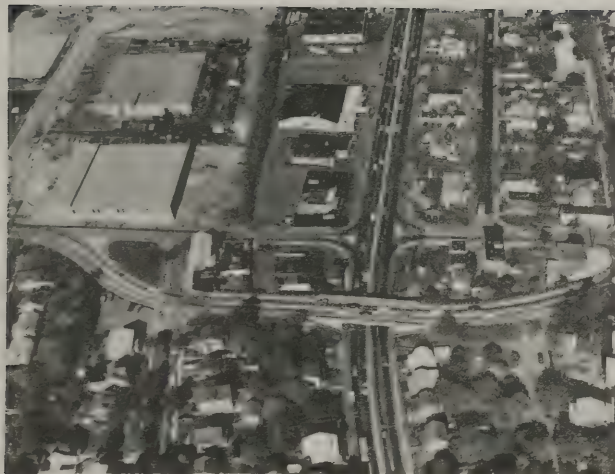
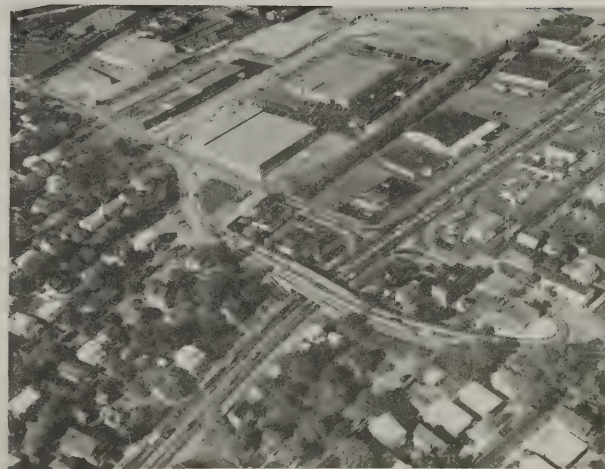
Partial Cloverleaf

Year of Construction: 1941

Photographed 8/21/67 - 1700 hours
500' Altitude, Looking East

Photographed 8/21/67 - 1700 hours
800' Altitude, Looking Northeast

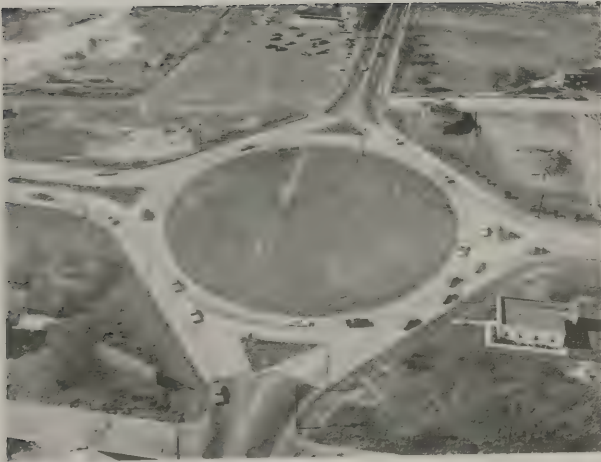
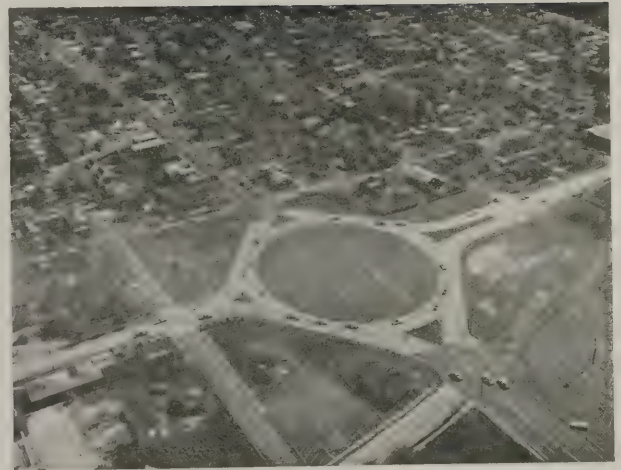
Traffic Circle

Year of Construction: 1940

Photographed 5/18/67 - 1700 hours
500' Altitude, Looking North

Photographed 5/18/67 - 1700 hours
700' Altitude, Looking Southwest

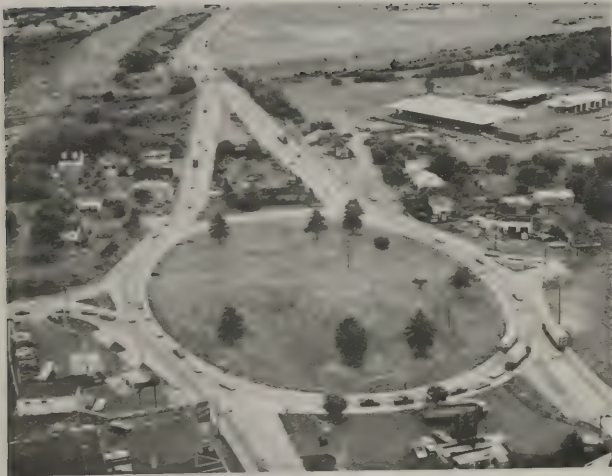
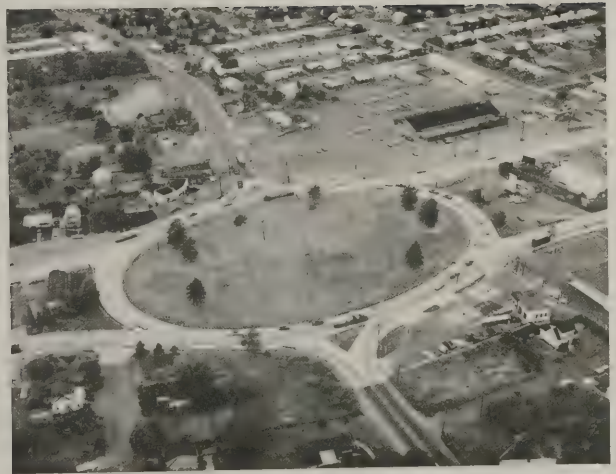
Traffic Circle

Year of Construction: 1929

Photographed 6/29/67 - 1700 hours
500' Altitude, Looking South

Photographed 6/29/67 - 1700 hours
700' Altitude, Looking West

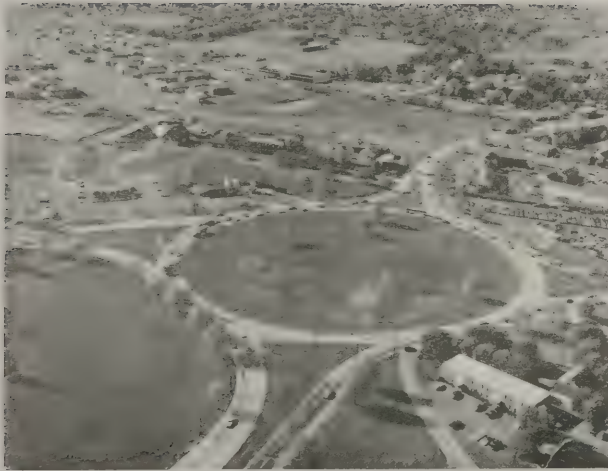
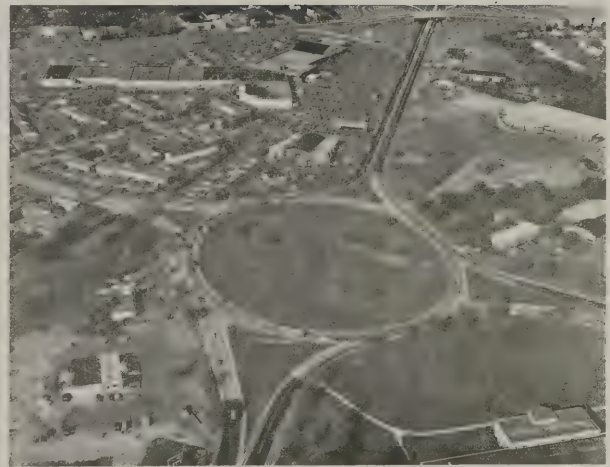
Traffic Circle

Year of Construction: 1941

Photographed 8/21/67 - 1730 hours
500' Altitude, Looking Northwest

Photographed 8/21/67 - 1730 hours
1000' Altitude, Looking Northeast

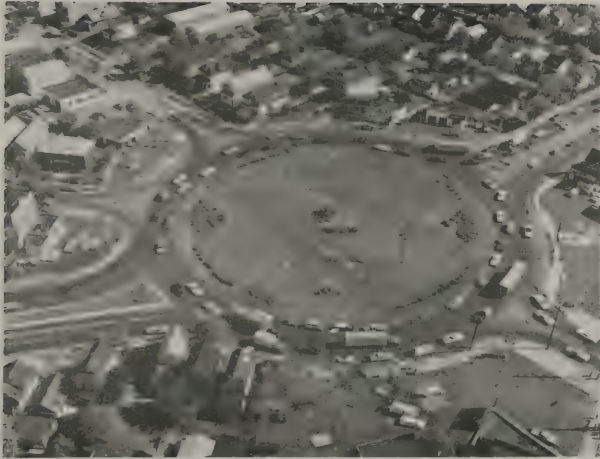
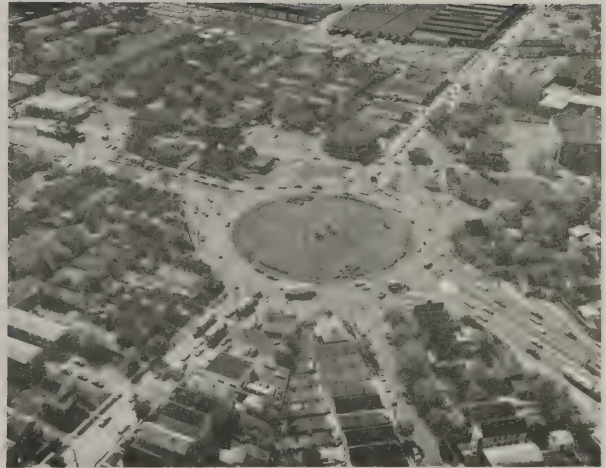
Traffic Circle

Year of Construction: 1929

Photographed 5/18/67 - 1700 hours
500' Altitude, Looking Southeast

Photographed 5/18/67 - 1700 hours
700' Altitude, Looking West

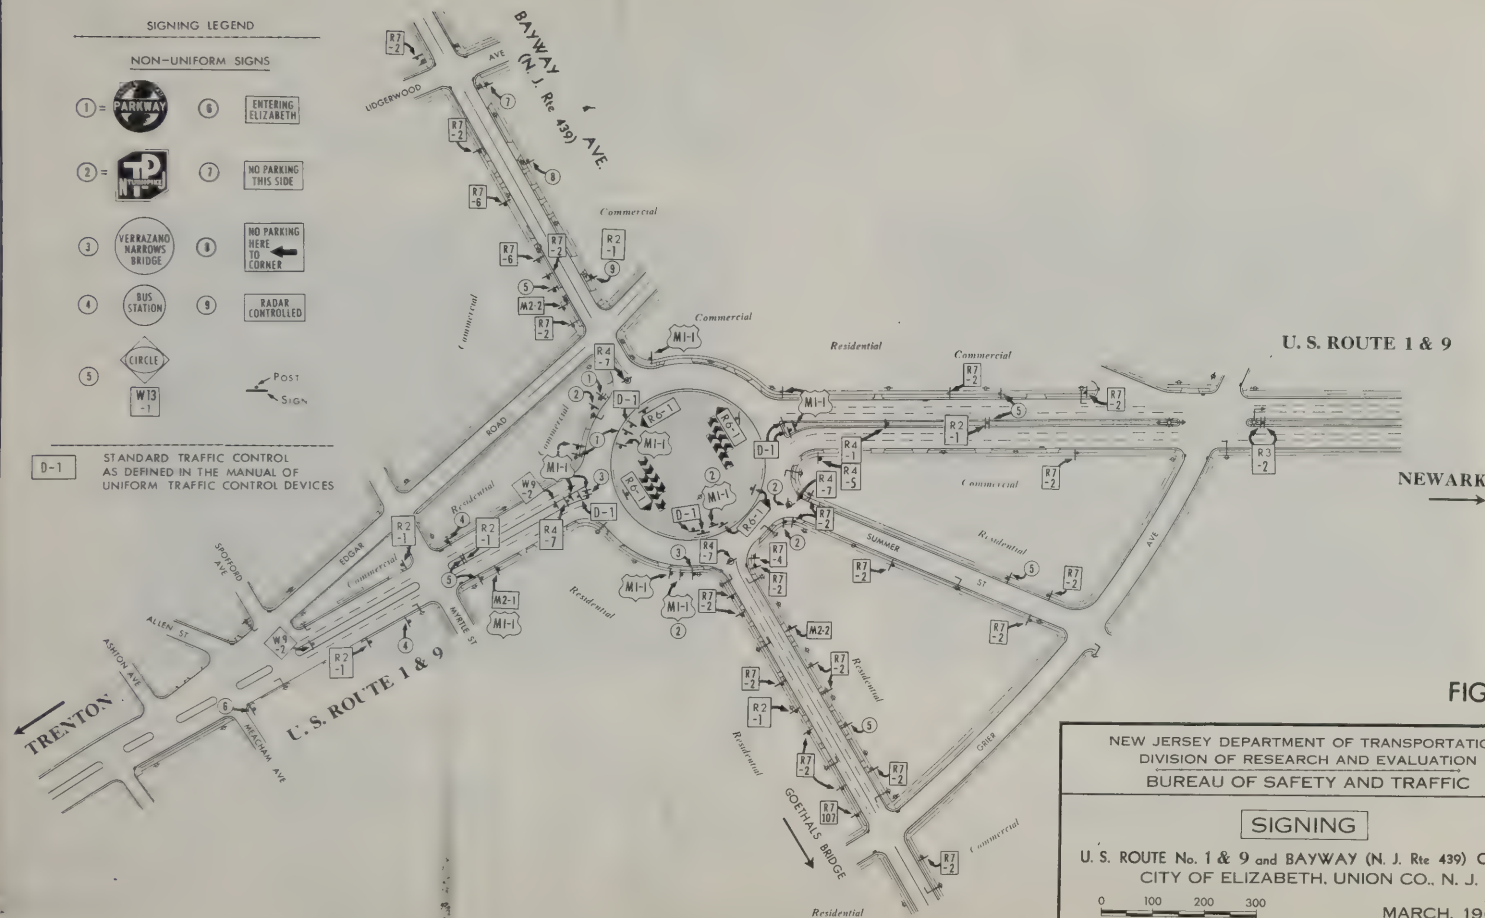
FIG. 14b

D-1 STANDARD TRAFFIC CONTROL AS DEFINED IN THE MANUAL OF UNIFORM TRAFFIC CONTROL DEVICES

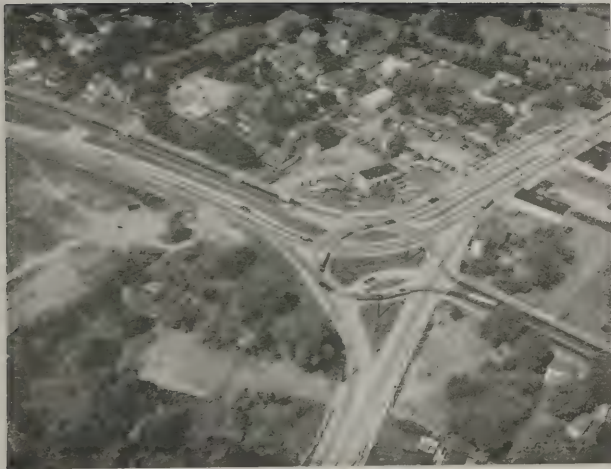
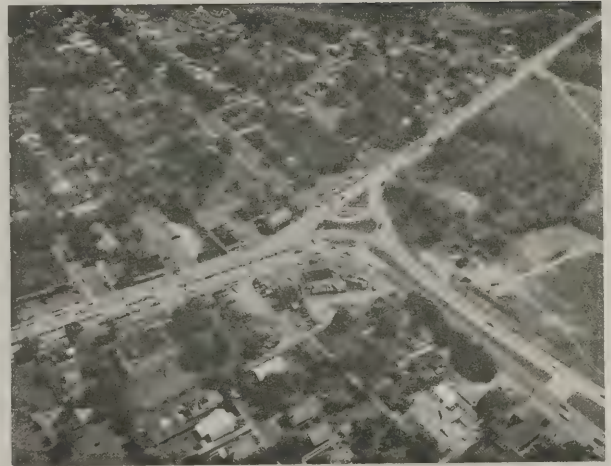
Channelized Traffic Circle

Year of Construction: 1947

Photographed 5/17/68 - 0930 hours
500' Altitude, Looking West

Photographed 5/17/68 - 0930 hours
800' Altitude, Looking East

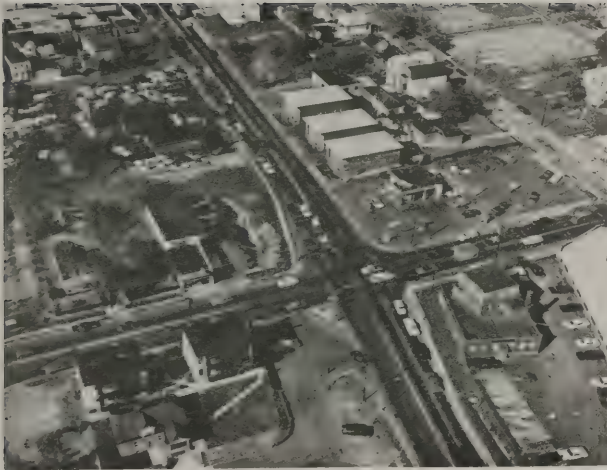
Photographed 8/21/67 - 1730 hours
500' Altitude, Looking Northeast

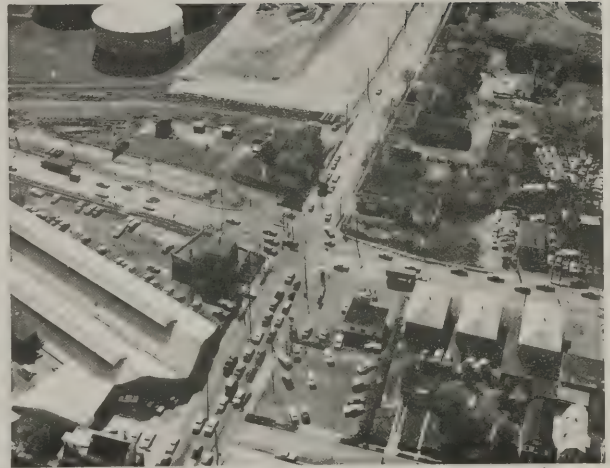
Photographed 8/21/67 - 1730 hours
800' Altitude, Looking West

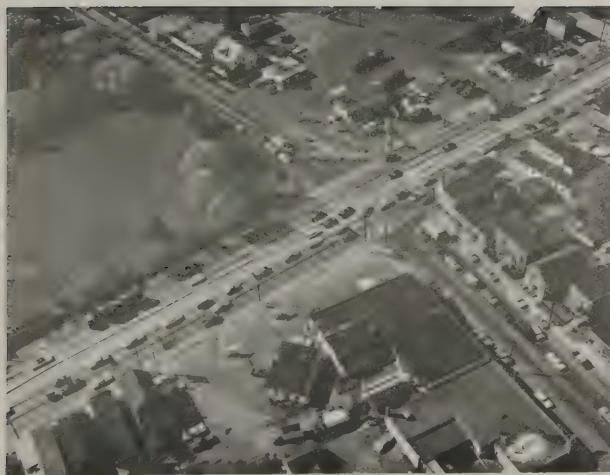
PHOTO 20

U.S. Route 1-9 and Wood Avenue

Signalized Intersection

Photographed 8/21/67 - 1715 hours
500' Altitude, Looking Northwest

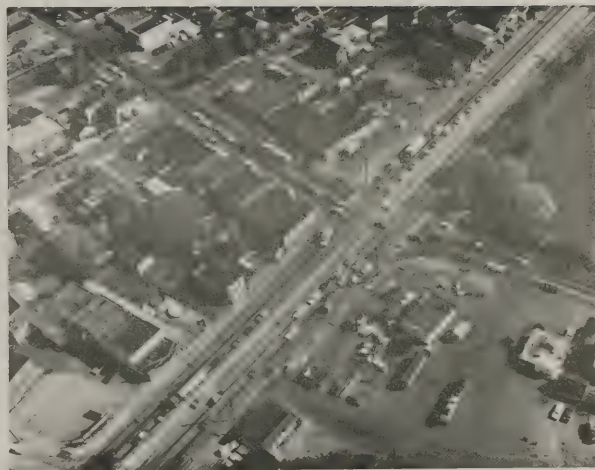
Photographed 8/21/67 - 1715 hours
800' Altitude, Looking Southwest

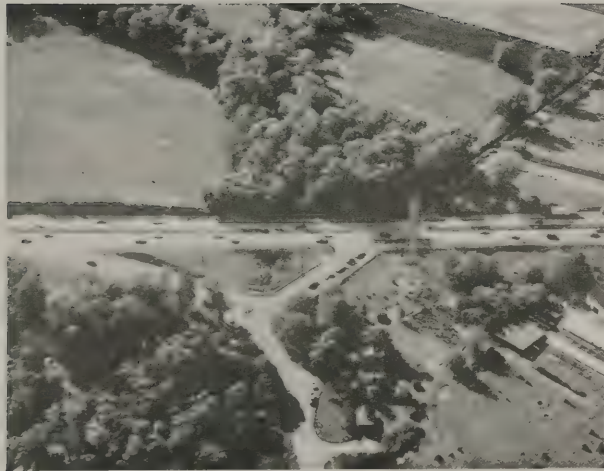
PHOTO 24

U.S. Route 1 and Ryders Lane

Signalized Jughandle

Photographed 6/1/67 - 1730 hours
500' Altitude, Looking Southwest

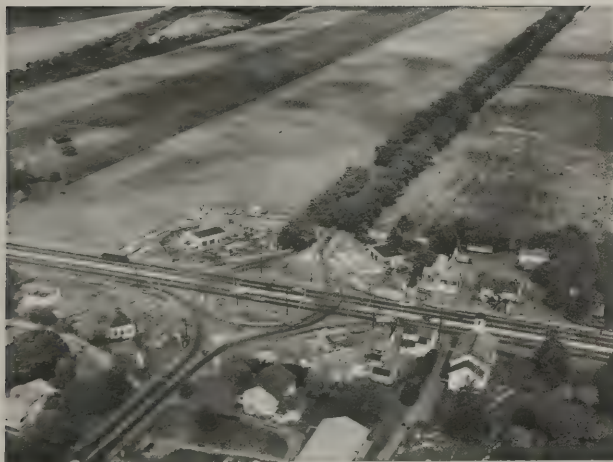
PHOTO 26

U.S. Route 1 and Washington Avenue

Signalized Through Circle

Photographed 5/17/68 - 0915 hours
500' Altitude, Looking West

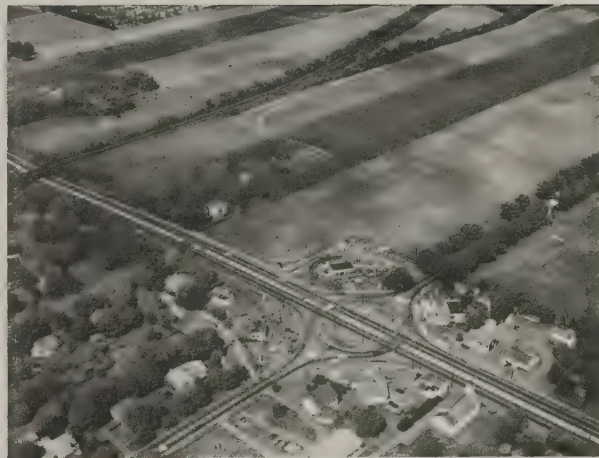
Photographed 5/17/68 - 0915 hours
800' Altitude, Looking Southwest

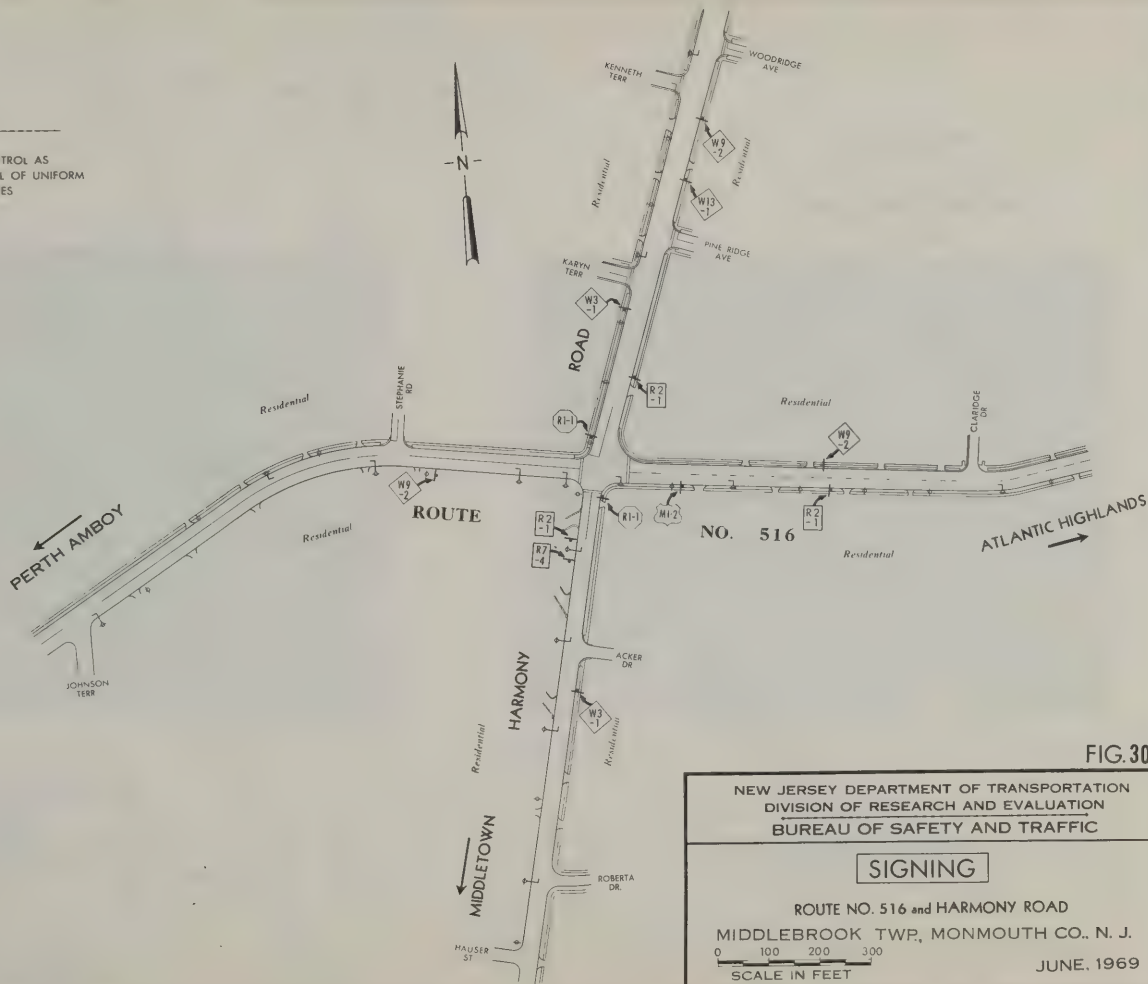
FIG. 30b

D-1 = STANDARD TRAFFIC CONTROL AS
DEFINED IN THE MANUAL OF UNIFORM
TRAFFIC CONTROL DEVICES

POST
SIGN
